An Analytical study and conservation of bronze windows grilles in Sabil Al-Ahmadi, Tanta, Egypt

Mostafa Ibrahim Eladawy¹, Mohamed M. Megahed², Nabil Abdel Ghany³ & Mohamed Abdelbar⁴

Keywords: Quaternary bronze, Window grille, Corrosion, Analysis, Conservation.

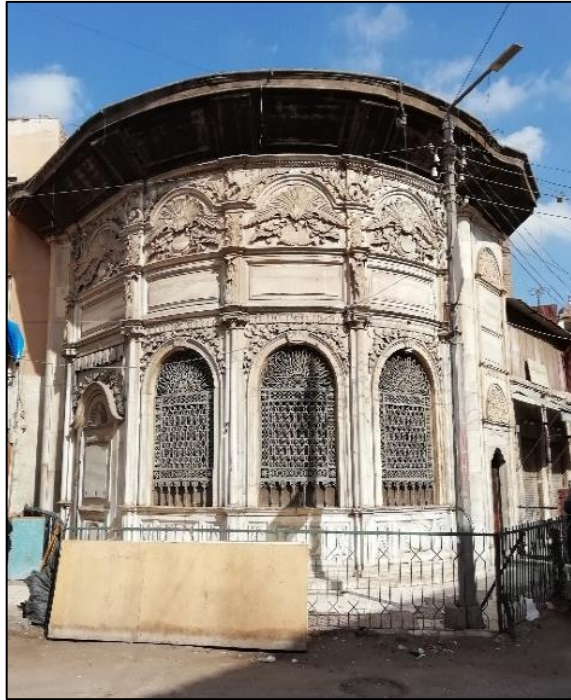
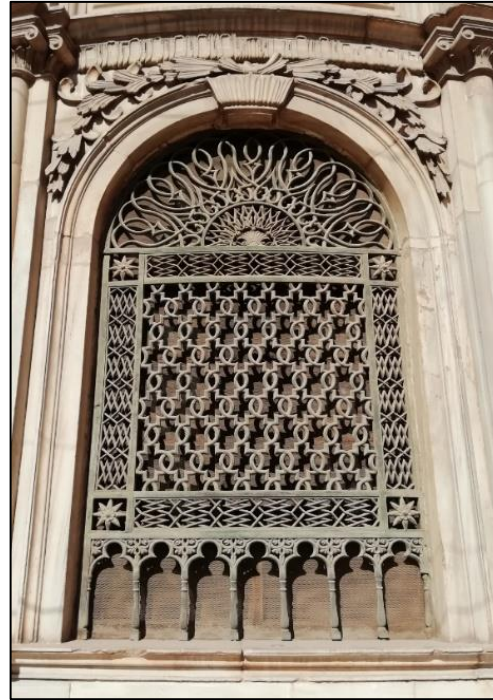
Fig. 1. (a) Shows the exterior facade of the Sabil Al-Ahmadi, and (b) depicts the middle bronze window, the selected case study.

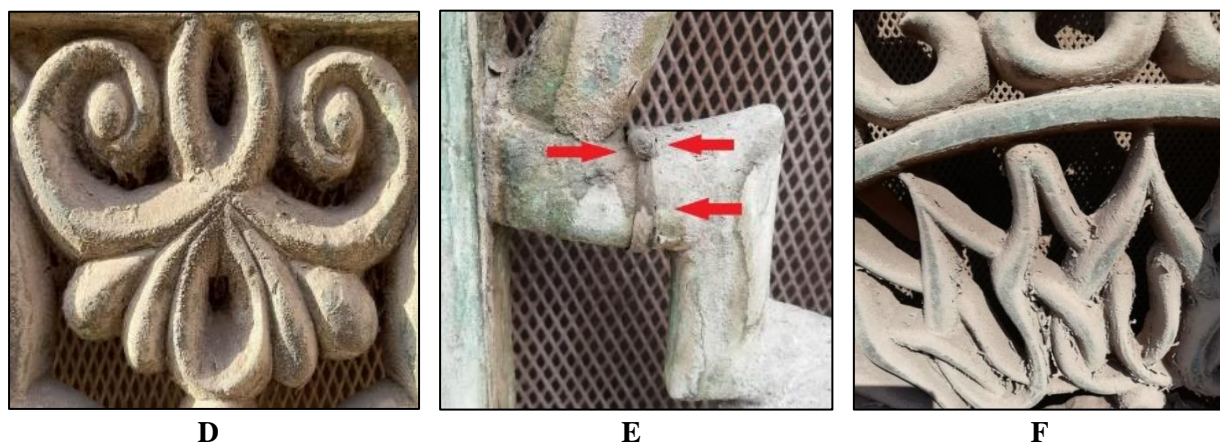
Fig. 4. (A, B, C) show the accumulation of dust covering the floral decorations. (D, F) show green corrosion products mixed with calcifications filling the gaps between the mesh grilles. (E) shows cloth ties placed by visitors to the Sabil Al-Ahmadi, marked with red arrows.

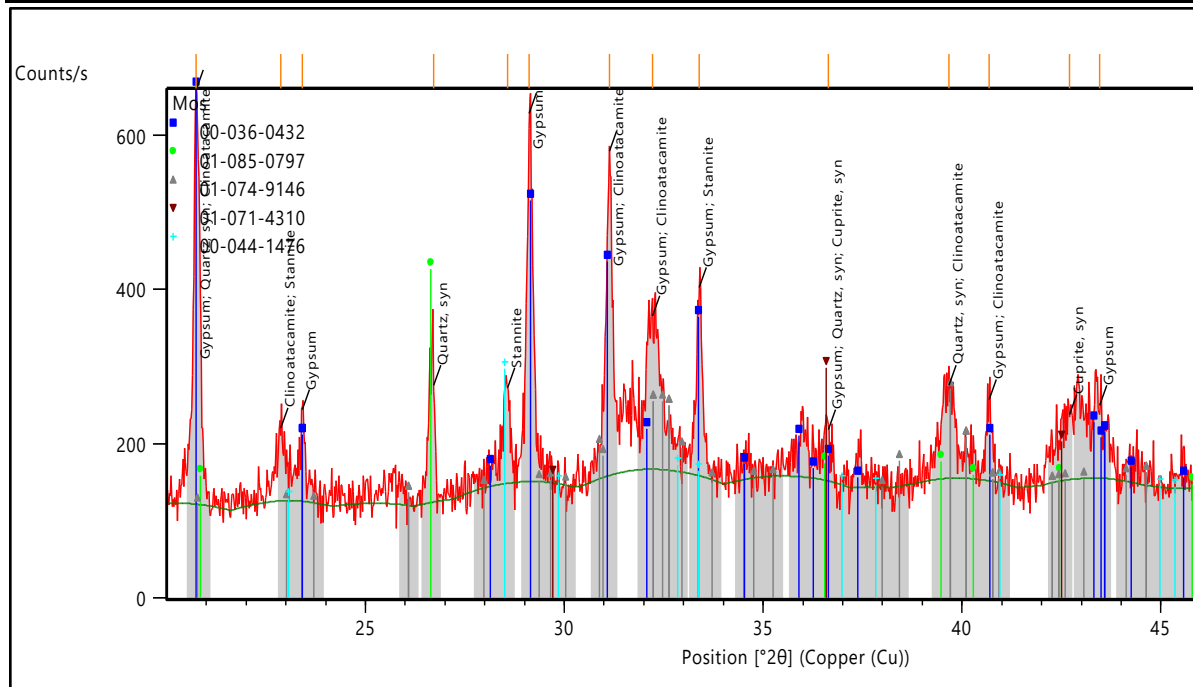
The X-ray diffraction (XRD) analysis identified several compounds on the surface of the alloy, including clinoatacamite (Cu₂(OH)₃Cl), cuprite (Cu₂O), calcite (CaCO₃), quartz (SiO₂), and gypsum (CaSO₄·2H₂O), as illustrated in Fig. 10 and detailed in Table 3. These compounds signify various stages and types of corrosion processes affecting the Sabil window, which has been exposed to outdoor environmental conditions. The initial corrosion product formed on copper artifacts in the atmosphere is cuprite, which gradually reacts with oxygen and airborne pollutants like SO₂, Cl⁻, and CO₂ to form basic salts. The moisture content and concentration of air pollutants are critical factors influencing the rate of corrosion, which occurs through a wet corrosion mechanism due to water adsorbed on the metal surface. The thickness of this moisture layer varies about 100 microns from rain, 10 microns from condensation, and approximately one micron at 100% relative humidity. The rate of corrosion is closely linked to the duration of this moisture layer on the metal, which is influenced by atmospheric humidity, temperature, rainfall, sunlight, and air pollution levels. Given that copper, the primary component of quaternary bronze, is an electropositive metal, the predominant corrosion mechanism involves electrochemical reactions where copper oxidizes and forms cupric salts in the presence of anions such as sulfates, hydroxides, and phosphates^{51,52,53,54,55,56}.

Clinoatacamite forms in the presence of chloride ions common in marine or urban environments. Its presence suggests chloride ions have reacted with the copper, forming a green corrosion product. Chloride corrosion compounds on the Sabil window were due to air pollutants and the use of tap water containing chlorine ions for periodic washing^{57,58}. The facade of the Sabil is completely covered with marble tiles, and workers have regularly washed the facade and windows with tap water. Calcite forms from calcium ions in rainwater or dust reacting with carbon dioxide. Quartz, common in dust and dirt, and gypsum, from sulfur dioxide reacting with calcium compounds, suggest significant deposition of environmental particulates and pollutants. These compounds trap moisture and pollutants against the metal surface, exacerbating corrosion. Exposure to outdoor conditions subjects the window to rain, humidity, and temperature fluctuations. Urban environments with higher pollutants like chlorides and sulfur compounds exacerbate corrosion. Rainwater and humidity provide electrolytes for electrochemical corrosion, dissolving airborne pollutants and forming acidic solutions that accelerate corrosion. Variations in temperature cause the metal to expand and contract, leading to microcracks in the protective oxide layer and further ingress of corrosive agents⁵⁹.

Fig. 10. shows XRD spectrum of corrosion products and dust accumulated on the window surface.

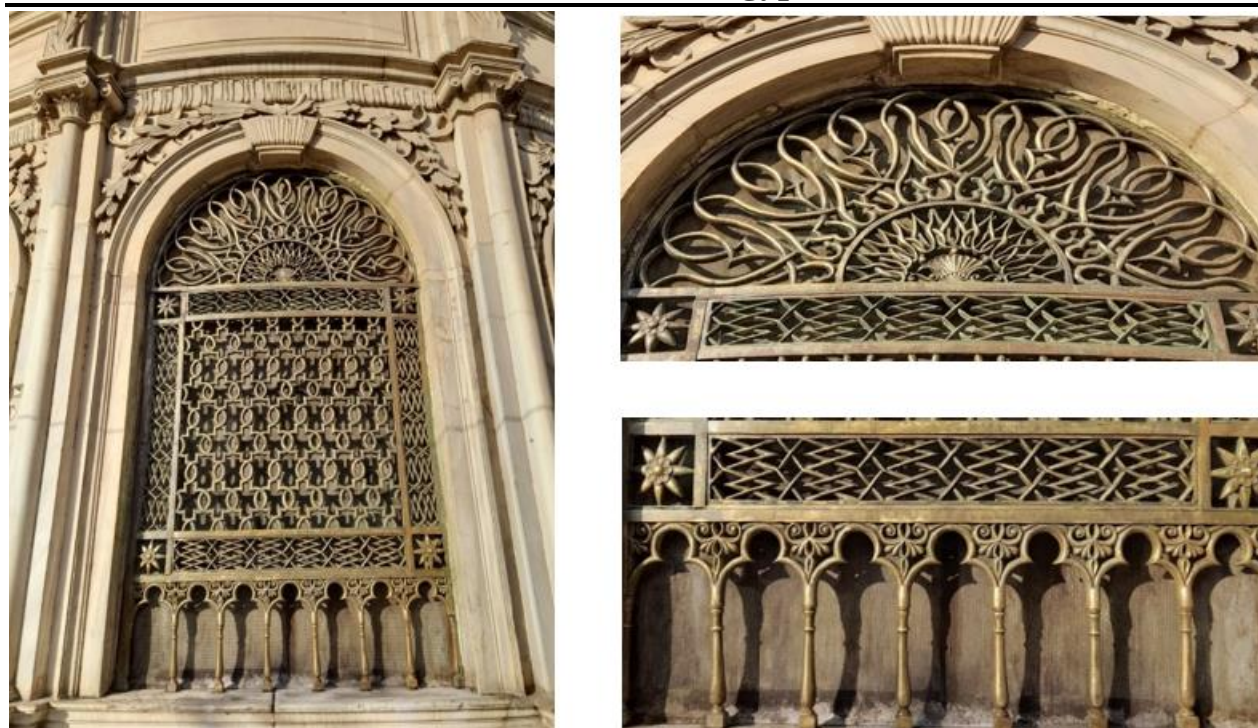
Fig. 13. shows the window grille after cleaning and protection.
